PHOTOGRAPHIC INSERPRETATION REPORT

SURFACE-TO-AIR MISSILE FACILITIES
KAPUSTIN YAR/VLADIMIROVKA
MISSILE TEST CENTER, USSR

NPIC/R-126/63

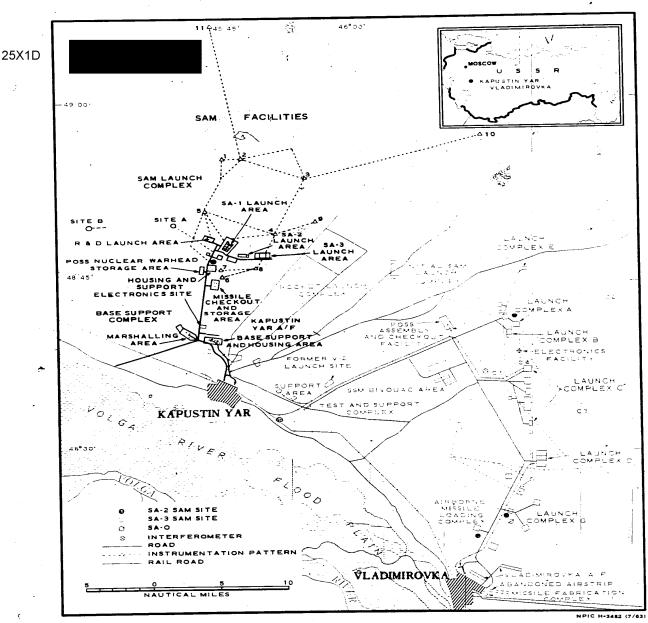
FIGURE 1. KAPUSTIN YAR/VLADIMIROVKA MISSILE TEST CENTER.

Since the coverage, there has been continuing expansion within the SAM Facilities at the KYMTC (Figures I and 2). The major expansion observed is within the SAM Launch Complex where additional launch sites have been constructed in the R & D Launch Area, the SA-2 Launch Area (formerly the Troop Training Launch Area 1/), and the SA-3 Launch Area (formerly the New-Type SAM Launch Area 1/). Other developments include enlarged storage and housing facilities, an improved airfield runway, a probable radar control center, an operational SA-2 site, two SA-3 training sites west of the SAM Launch Complex, and three new instrumentation sites.

Since Instrumentation Site 1 has been abandoned. Instrumentation Site 3--which formerly had no permanent buildings--now has two buildings located within the site area. Instrumentation Site 8 is now surrounded by two graded firebreaks. Three instrumentation sites have been added to the SAM Test Range (Figure 1).

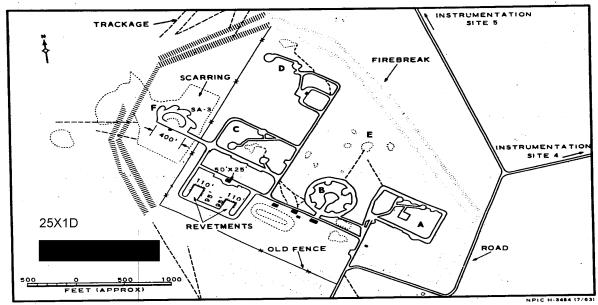
FIGURE 3. R & D LAUNCH AREA.

An SA-3 launch site (Site F) and two large vehicle or equipment revetments have been added to the western half of the R & D Launch Area (Figure 3). Site F is similar to Site B in the SA-3 Launch Area. It is semicircular and measures approximately 400 by 275 feet. The four launch positions are 50-55 feet in diameter;

they are outside the semicircular service road

and connected to it by short spur roads. The revetted guidance area, 80 by 80 feet, is at the approximate radial center of the site. A small building is located south of the guidance area. In the site appeared complete but inactive.

The two new revetments, each approximately 110 by 95 feet, are U-shaped and may accommodate vehicles or other equipment. Both revetments contained unidentified objects in

They are located on the south side of a rectangle formed by a new concrete road. A possible drive-through building, 50 by 25 feet, is located on the north side of the rectangle.

Of the five original launch sites (Sites A-E) in the R & D Launch Area, only Site B was operationally active in Vehicles or equipment were visible on the guidance pad and several of the launch points may have been occupied.

New construction is apparent only at Site D or the original five launch sites. At Site D, a concrete service road--half of which was observed on earlier photography--has been completed and a hardstand and a possible drive-through building have been added. Both serve the circular concrete pad present in There has been no significant change since in the YO YO guidance site associated with the R & D Launch Area. The firebreak, which formerly bulged on the north

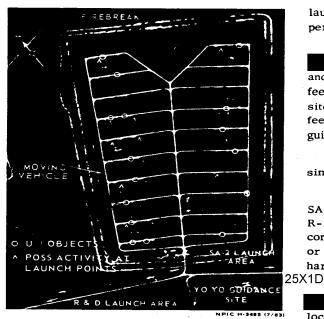
FIGURE 4. HERRINGBONE LAUNCH AREA

The Herringbone Launch Area appeared active Sixteen unidentified objects were observed on the roads at positions between launch points where missile transports or dollies would normally be parked (Figure 4). At 12 of the launch points, a slim dark pattern was observed in locations where launchers were specifically identified on earlier TALENT photography. However, the type of activity at the Herringbone Launch Site cannot be determined because of the small scale of the later KEYHOLE photography. A moving vehicle was seen on the outer access road serving the west side of the site.

There is apparently only one change since in the YO YO guidance site associated with the Herringbone Launch Area. A small building on the east side of the area has been removed.

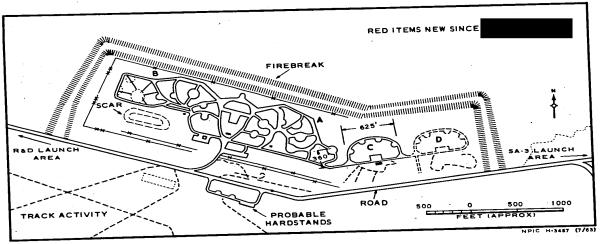
FIGURE 6. SA-2 LAUNCH AREA.

East of these sites, in the area formerly occupied by three of the training sites, are two new launch sites (C and D), which are different in configuration from Sites A and B (Figures 5 and 6). They are semicircular and have four

launch positions located along the inside of a perimeter service road.

Site C appeared complete but inactive in It is approximately 625 by 360 feet and has four unrevetted launch positions 55-60 feet in diameter. Near the radial center of the site is an unrevetted guidance area 110 by 75 feet. A probable building is located south of the guidance area.

Site D, under construction, appears to be similar to Site C in size and configuration.

Sites C and D are similar to the deployed SA-0 SAM sites previously reported in NPIC/R-r23/62 as new-type SAM Sites. This report concluded that they are probably part of a new or modified SAM system rather than merely hardened training sites.

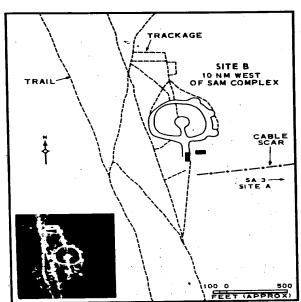
FIGURE 8. PROBABLE SA-3 TRAINING SITES

Two SA-3 sites (Sites A and B) are located west of the SAM Launch Complex at 48-49-40N 45-38-20E and 48-49-10N 45-30-00E, respectively. They are similar in size and configuration to the newly constructed Site D in the SA-3 Launch Area within the SAM Launch Complex (Figure 8). However, neither site appears to have the same number of launch or hold positions as does Site D. This apparent difference may result from poor-quality photography or earth

scraping which obscures the configuration of some of the positions, or the sites may still be under construction. Security fences were not apparent at either site. Neither site appeared active in Cable scars indicate the sites utilize the existing test range facilities of the SAM Launch Complex.

At Site A, three launch positions and one hold position are discernible along the outside of a circular service road. The launch positions and the guidance area do not appear to be revetted. Two possible buildings are located at the site. A cable scar extends east from the site to the SAM Launch Complex.

At Site B, two launch positions and one hold position are discernible along the outside of a circular service road. The launch positions and the guidance area do not appear to be revetted.

Two support buildings are visible. A possible cable scar extends east from Site B toward Site A.

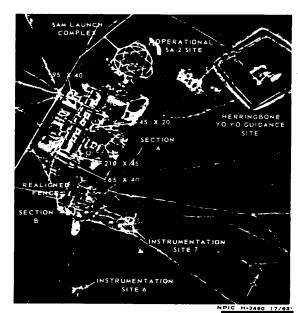
FIGURE 9. HOUSING AND SUPPORT AREA

A barracks building, 210 by 45 feet, and two support buildings, 95 by 40 feet and 45 by 20 feet, have been added to Section A of the Housing and Support Area (Figure 9). The barracks building was under construction in A fourth building, approximately 65 by 40 feet, is now located south of Section A adjacent to the security fence. This fence has been changed since previous coverage and excludes the fourth building from the secured area. Two storage buildings have been removed from Section B.

An operational SA-2 site is located between the Herringbone YO YO Guidance Site and the Housing and Support Area (Figures 2 and 9). The

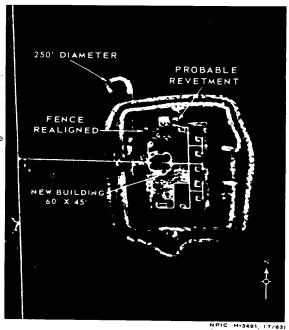
FIGURE 10. MISSILE CHECKOUT AND PROPELLANT STORAGE AREA

A second drive-through building--which has a possible gable roof and measures approximately 60 by 45 feet--has been completed (Figure 10). The foundation for this building was apparent It is located opposite the drive-through checkout/maintenance building identified on earlier TALENT photography and south of that previously reported facility. The curved concrete roads serving these buildings are simi-

lar in design and come together to form a circular pattern, suggesting that the two buildings are associated in function.

A possible counterpart to the revetted structure on the south perimeter of the area is being constructed on the north perimeter. In however, only a prepared area, 200 feet square, with construction activity on its south edge was evident. The construction lies between the double security fence.

An area approximately 250 feet in diameter and surrounded by a firebreak is located outside the northwest edge of the Missile Checkout and Propellant Storage Area. The area with its firebreak was present on photography; at that time it appeared to contain open storage. A trail leads from this area to the Missile Checkout and Propellant Storage Area.

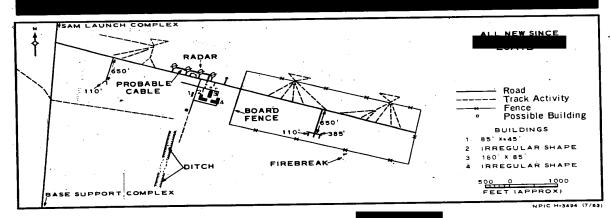
, FIGURE 13. ELECTRONICS SITE

A new radar site has been identified since within the SAM Facilities (Figure 13). It is located 2 nm north of the Base Support Complex and 5.5 nm south of the SAM Launch Complex on the east side of the all-weather road connecting these two complexes.

Four similar radars on mounds are arranged in a straight line on the north side of the main road serving the radar site. A small revetment is located between the two inner radars, and a small building is located east of the radars.

South of the service road are four large buildings. A rectangular-shaped building measures 180 by 85 feet; an L-shaped building measures 185 feet on its long side, 120 feet on its short side and is 55 feet wide; another L-shaped building is 115 feet on both sides and 55 feet wide. Both L-shaped buildings have concrete aprons.

The fourth building measures 85 by 45 feet. One definite and two possible small buildings are also located in the vicinity. A probable buried cable connects the four radars with one of the large buildings. A probable board security fence is visible only on the east side of the site. Heavy trackage in the area indicates that the site is still under construction.

The number of buildings at the site is greater than is necessary to support the four radars. The site, therefore, may be the central control for similar radars which may possibly be located in the area. The arrangement of the radars resembles those at Vladimrovka Airfield, which have been rearranged in a straight line on mounds.

A secured area, 3,400 by 1,400 feet, was photography east of the observed on radar site and adjoining it. Photography of revealed an extension of the main service road of the radar site eastward to the limits of the secured area. Unidentified construction is visible south of the road extension and heavy trackage is evident to the north. The construction appears to be a T-shaped road with three straight prongs jutting from the crossbar of the "T." This T-shaped road--which is located east of the large buildings in the radar site--appears to balance a probable road with two curved prongs which was observed west of the large buildings on photography of roads are 650 feet in length. The straight prongs are approximately 110 feet in length. The curved prongs form a U-shaped pattern which measures approximately 110 feet from base to top.
